# THE WURLITZER THAT WOULD NOT DE

# PART TWO

## by Bill Rieger

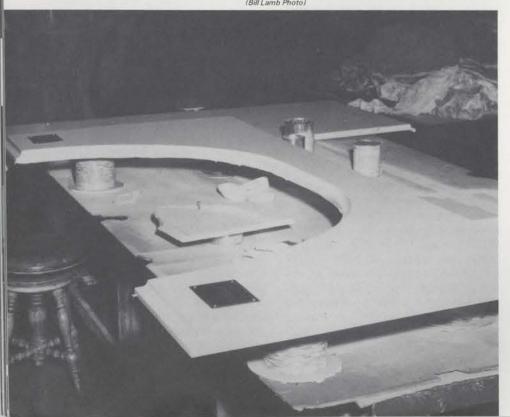
Console top in refinishing department (one of the old scenery rooms on 4th floor). (Bill Lamb Photo)

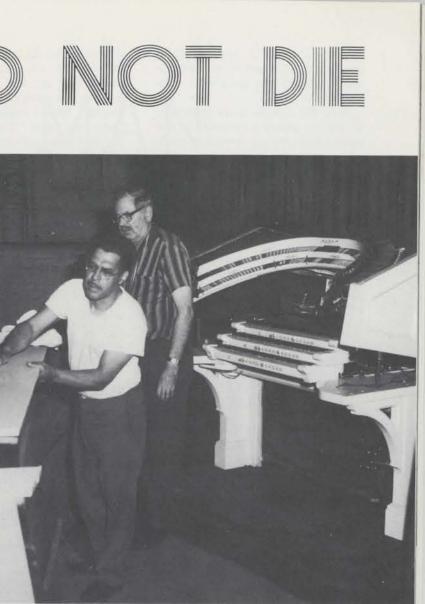
The finished front boards are ready for assembly (Val and George).

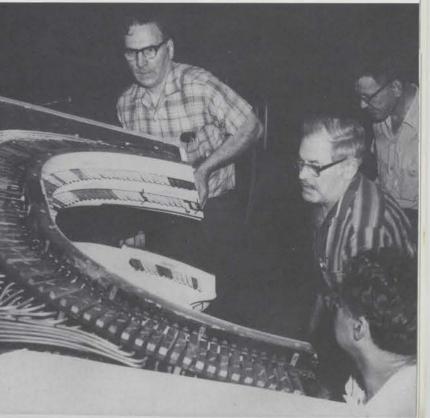
A serious moment as bolsters are lowered to position (Bill, Val, George, and Frank). (Bill Lamb Photo)
