**A Study of Effectiveness of Midblock Pedestrian Crossings:
Analyzing a Selection of High-Visibility Warning Signs**

Abstract

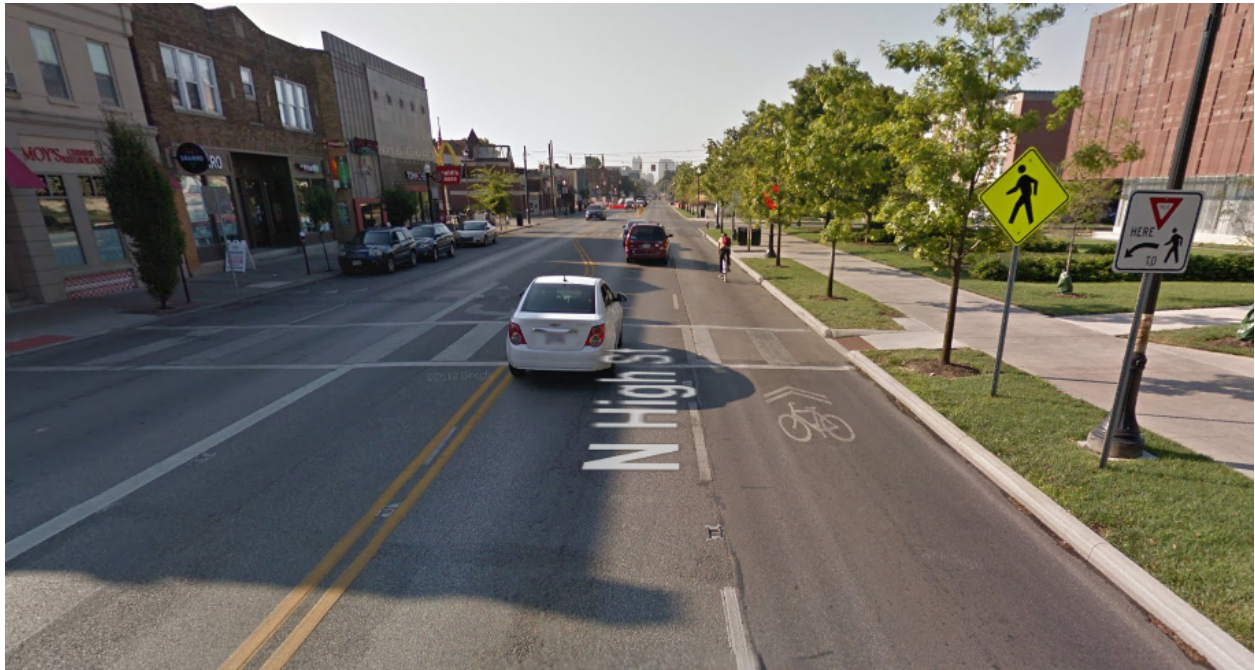
The first location, south of Woodruff Avenue and at about 18th Avenue, is shown in Map 1. This crossing has a diamond shaped pedestrian high-visibility sign side-mounted at the crosswalk, as shown in Figure 1. There is a “yield to pedestrians here” sign further upstream, pointing to a thick white line. The crosswalk is striped and visible. There is a row of triangles leading up to the

crosswalk as well. These signs and pavement markings exist in both directions of travel.

Figure 1: Crossing conditions on High Street south of Woodruff Avenue, at about 18th Avenue (Google Maps)

Table 1 shows the observations from this crossing. These observations revealed a low vehicle yield rate, similar to that of which the literature found with these standard signs. There were 14 crossing groups, totaling 24 pedestrians. The summary of the crossing data for this location are shown in Table 2. Of those crossing groups, eight (57.14%) made their eventual cross during a gap in traffic. Two (14.29%) were yielded to by a vehicle, and the remaining four (28.57%) crossed by stepping into the roadway and forcing traffic to yield to them. One near conflict occurred during a crossing, which happened at the opposite end from where the pedestrian began his crossing.

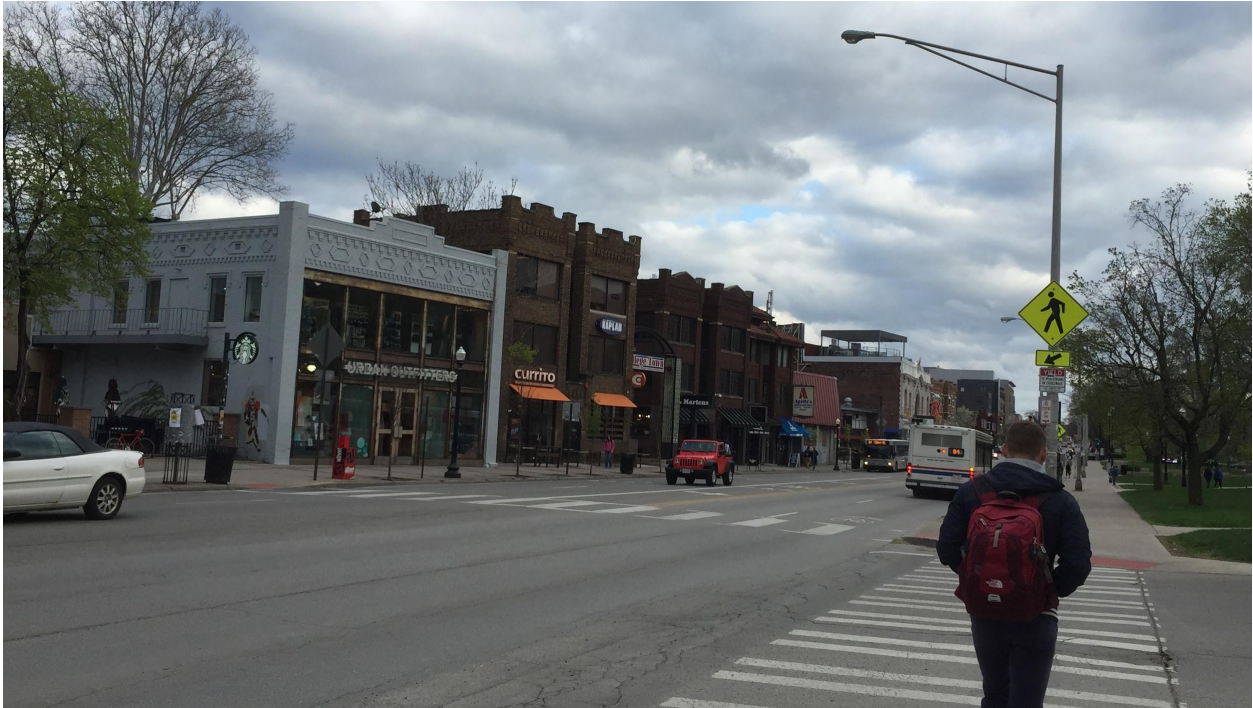
The second study of a midblock crossing on High Street is located in the same environment, at about 14th Avenue, a few blocks south of the first location (Map 2). This crossing has a diamond shaped pedestrian high-visibility sign side-mounted at the crosswalk, similar to the previous crossing. As shown in Figure 2, however, this sign also has a small rectangular high-visibility sign below the diamond sign with an arrow pointing towards the crosswalk. There is again a "yield to pedestrians here" sign further upstream, pointing to a thick white line. The crosswalk is striped and visible. There is a row of triangles leading up to the crosswalk as well. These signs and pavement markings exist in both directions of travel.

Figure 2: Crossing conditions on High Street south of Woodruff Avenue and at about 14th Avenue

Table 3 shows the observations from this crossing. Here, 33 pedestrian groups were recorded crossing, for a total of 47 pedestrians. The summary of this data is in Table 4. Of these 33 groups, 26 (78.79%) crossed during a gap, four (12.12%) received a yielded vehicle, and three (9.09%) forced a vehicle to yield to them. 10 (38.46%) of the 26 gap-crossing groups had to wait for a gap in traffic after arriving at the crosswalk. These waits ranged from one passing vehicle to 16.

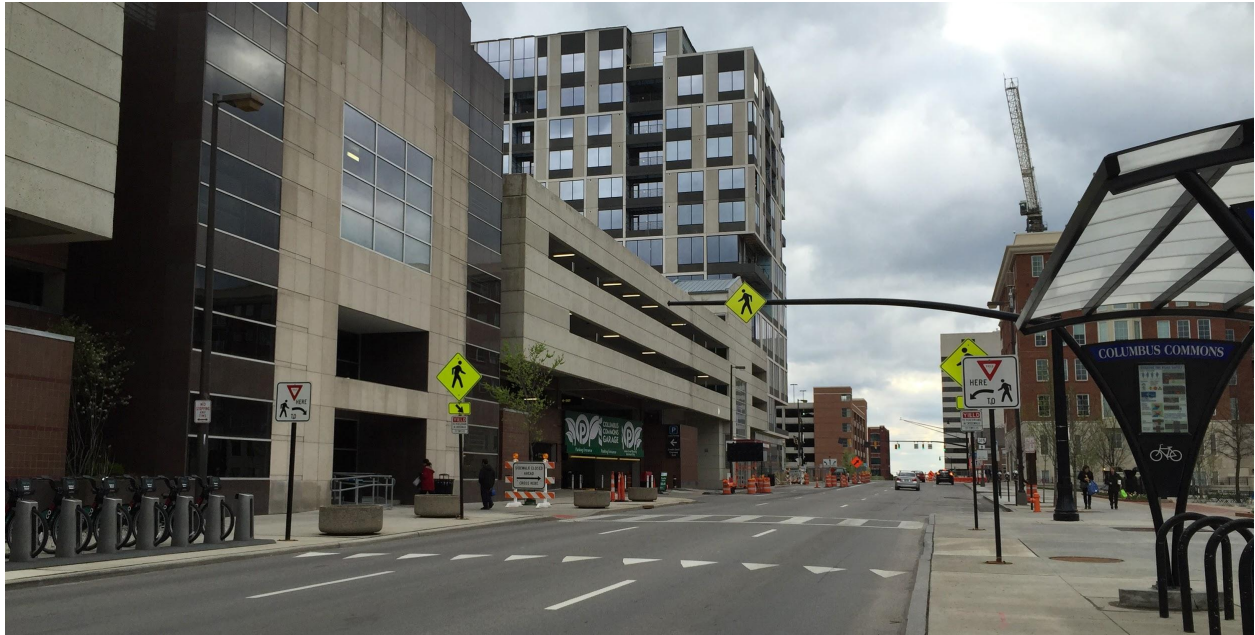
few hours a week. During the study, the event space was unused and functioned as an open green space. The street consists of three one-way lanes headed west. No posted speed limit was visible. The crosswalk is popularly used for crossing the street and heading into the garage. Signs posted at this location included the following: Diamond-shaped neon pedestrian sign with neon rectangular arrow on each side of street, "yield here to pedestrian" square sign each side of street, overhead diamond-shaped neon pedestrian sign. The crosswalk was striped and a row of triangles leading up to crosswalk was present (Figure 3). An important observation to make here is that, due to the one way nature of the road, both sides of the road displayed the same signs, which results in increased visibility of them by travel lanes.

Figure 3: Crossing conditions on Rich Street, in between 3rd Street and High Street in Downtown Columbus, Ohio. The garage can be seen here on the left.

The results of this observation are shown in Table 5. A total of 148 pedestrians crossed here during the observational period, in a total of 62 groups. The majority of pedestrians were observed to be business professionals leaving work for the day. Of the 62 groups, 45 (72.58%) were yielded to and the remaining 17 (27.42%) crossed during a natural gap in traffic. Table 6 shows these results summarized. There were no forced yields and no near conflicts. Only five (8.06%) groups had to wait for a vehicle to pass before they were able to cross. None of the gap-crossing groups had to wait for any passing vehicles. The five groups that had to wait for a yielding vehicle only had to wait for one passing vehicle each before the next vehicle yielded to them. This results in a yield rate of 80.00%.

This paper also hypothesizes a few more reasons why the location at Rich Street may have found more vehicles willing to yield. First, the overhead signage increases visibility of a crosswalk that all lanes are able to see. The majority of drivers, regardless of travel lane, would likely be able to see the warning signage. This may have a positive impact on yield rate. I would expect to find an increased yield rate if overhead signage was introduced at the locations on High Street. Second, the one-way road creates an environment in which side-mounted signage can be seen by two of the three lanes rather than two of the five lanes as seen on High Street. A warning is useless if it is not visible or obstructed by fellow drivers' cars.

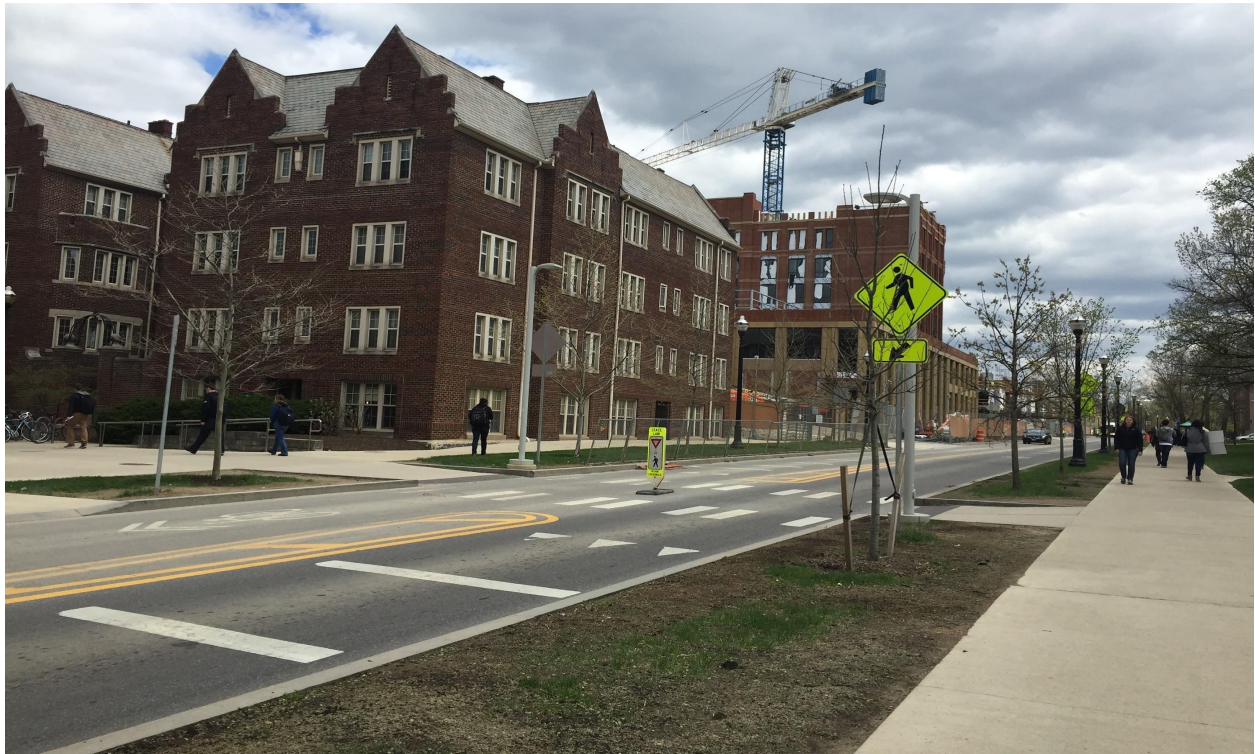
The final sign study conducted analyzed in-street signage. The location studied was on Woodruff Avenue in the Ohio State University, across from the Physics Research Building (Map 4). The road is a two lane, high pedestrian volume and high-moderate vehicle volume two way street. Pedestrian warning signs include a striped crosswalk with parallel striped lines leading up to crosswalk in each direction, diamond-shaped side-mounted neon pedestrian signs with downward arrows on each side, and an in-street “yield to pedestrian” sign in between the two lanes (Figure 4). The posted speed limit is 20 MPH.

Figure 4: In-street sign crossing conditions on Woodruff Avenue in the Ohio State University, across from the Physics Research Building

Observations at this location can be found in Table 7. There was a total of 253 crossing pedestrians in a total of 52 groups. 12 (23.08%) groups crossed the street during a natural gap in traffic and the remaining 40 groups (76.92%) crossed during a yield. This summary can be found in Table 8. There were no near conflicts or forced yields. Pedestrian group sizes ranged from one to 17, the largest of any location. Often, drivers would wait for additional approaching pedestrians in the same manner that was observed on Rich Street.

It was a safe crossing environment, however. The in-street signage, combined with narrow lanes, slow speed, and the high visibility of pedestrians waiting caused this crossing to meet the three criteria for “effective:” there were no near conflicts, there is high visibility of the pedestrian, and the yield rate is relatively high.
